**ADDENDUM NO. 2  
TO  
CONTRACT DOCUMENTS  
FOR  
653 COOK AVENUE**

This document has been assembled to aid Contractors in preparing their bids for this Project. The present condition of the property is one of mid-construction. Assessment has been taken of the work completed and recommendations are made as to; acceptance of the Work, unfinished Work, rejection of the Work, and Work to be completed. Photographs have been included, in each specification section where appropriate, to provide additional clarification.

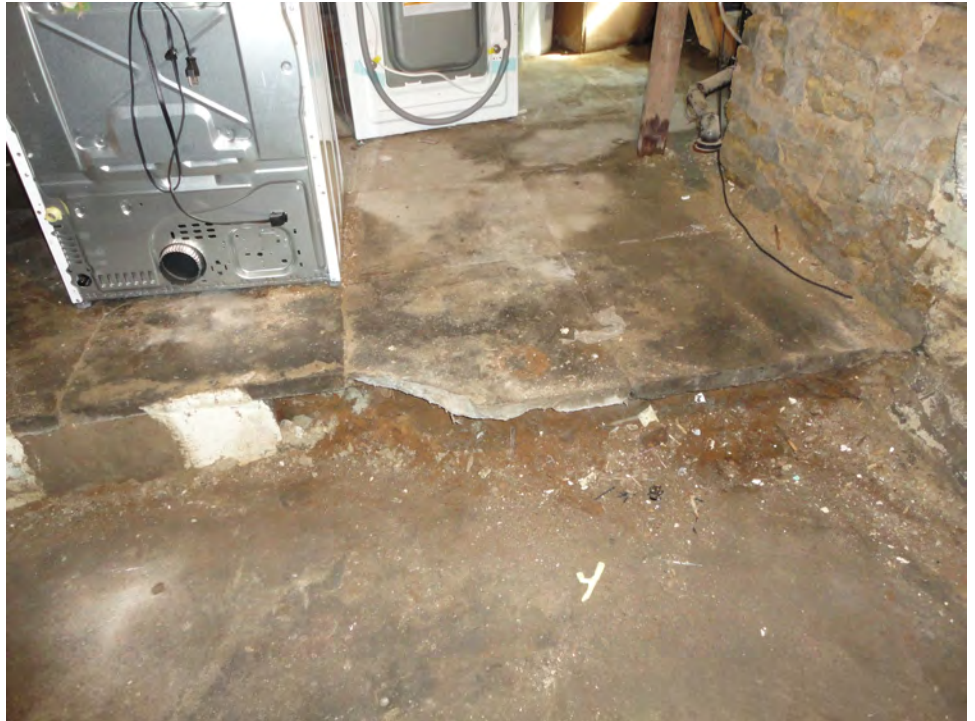
Condition of Basement Floor

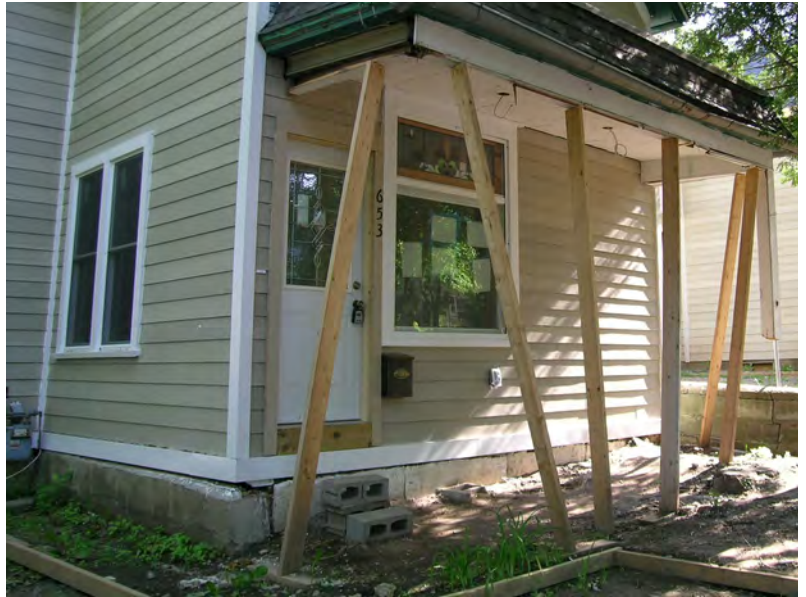
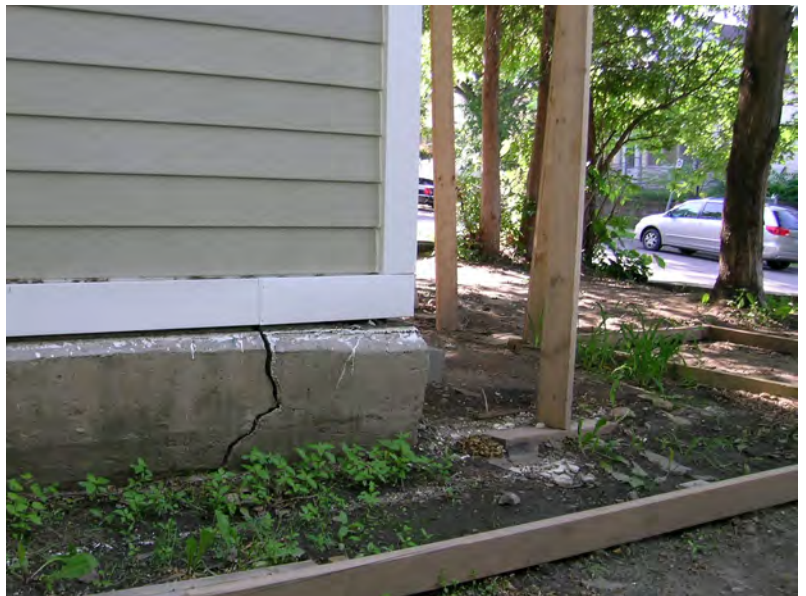
Southwest corner foundation cracked. See Sheet S101 for structural repair notes.

3. The front SW corner of the house foundation tuckpointing is incomplete. The new underpinned concrete pad footing has not been installed at the SW corner.

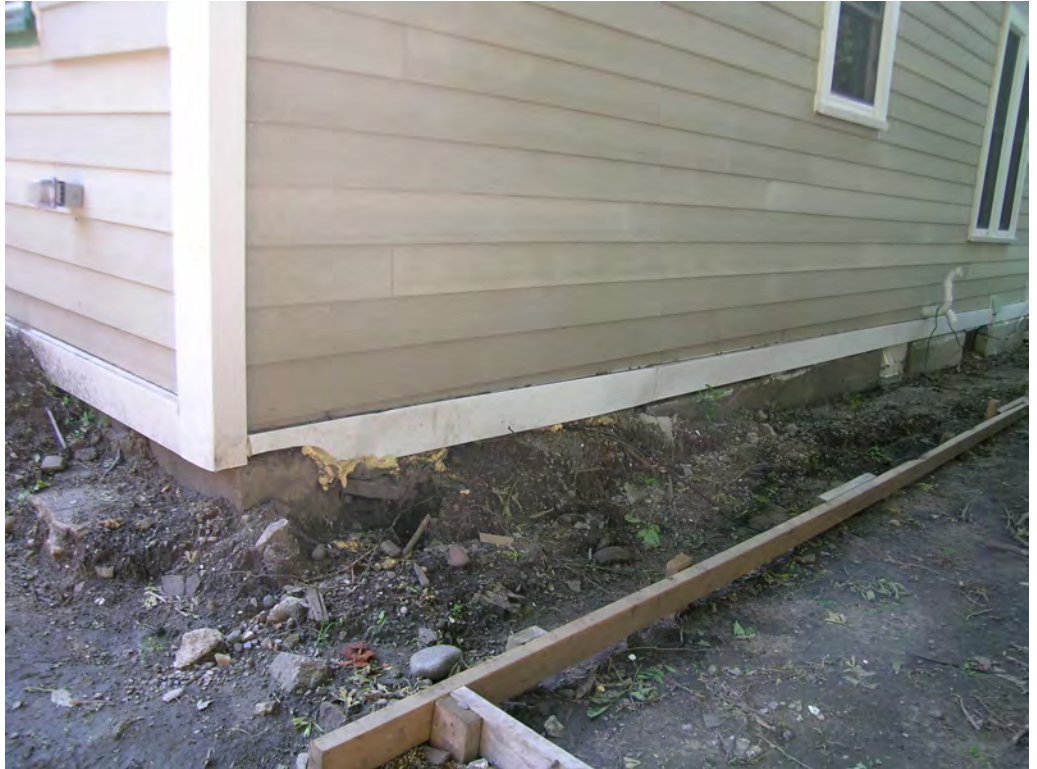
Missing foundation wall at northwest corner.

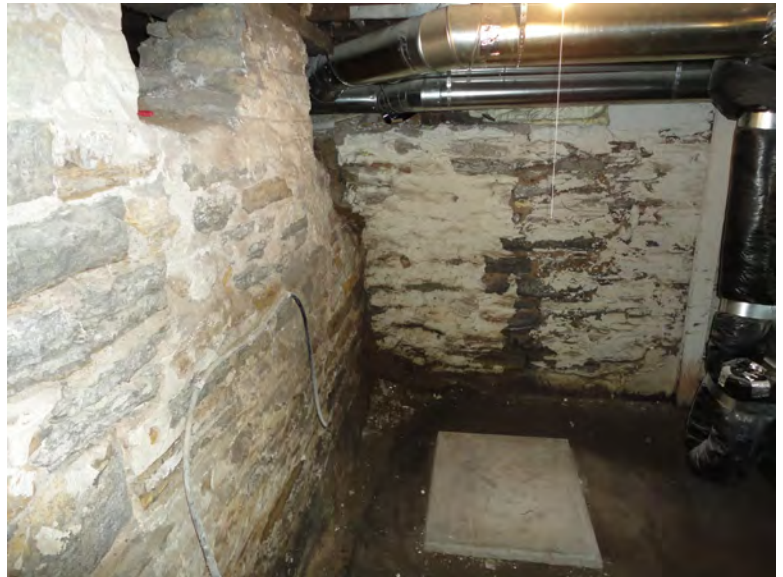
Pour new Basement floor where dirt floor exists

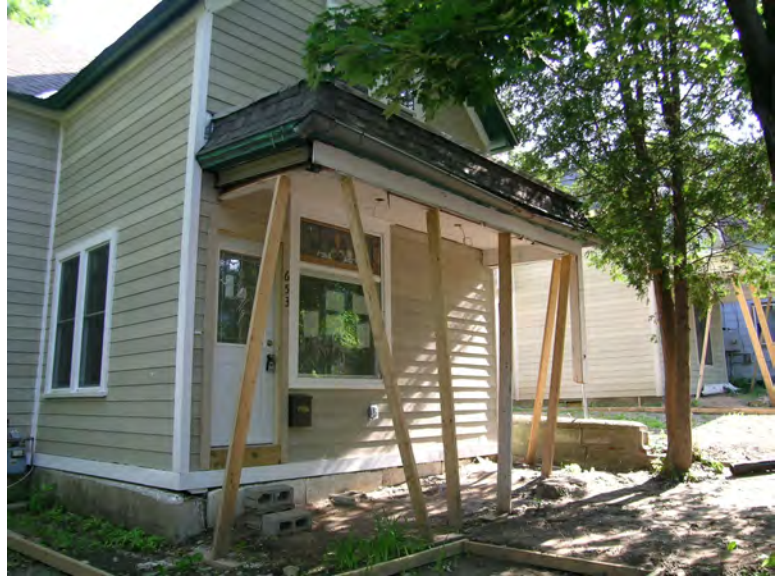
Footings for new porch

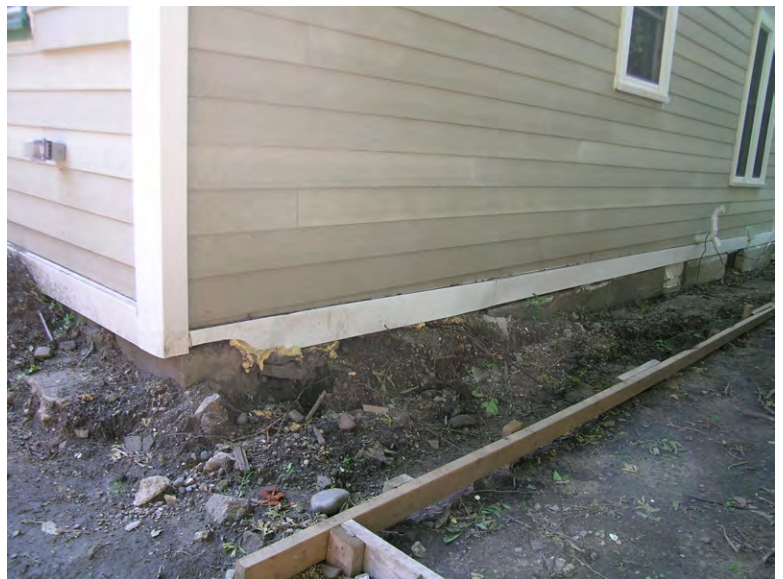
Missing foundation wall at northwest corner.

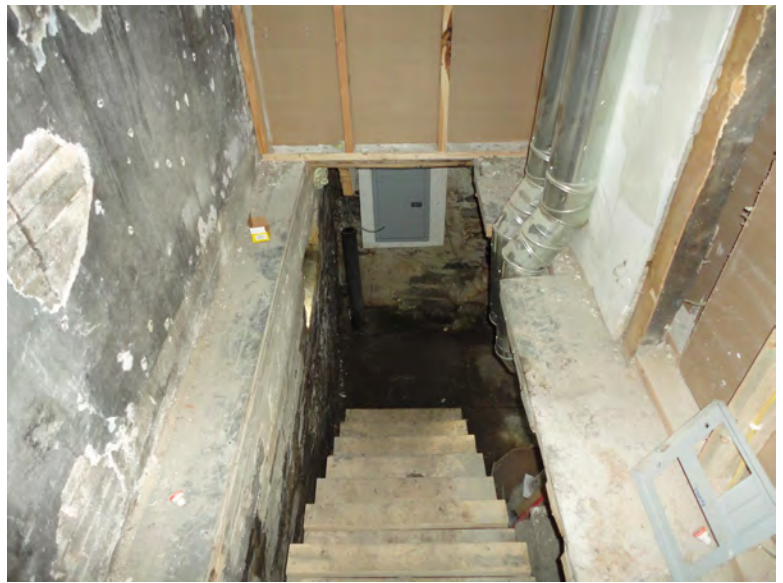
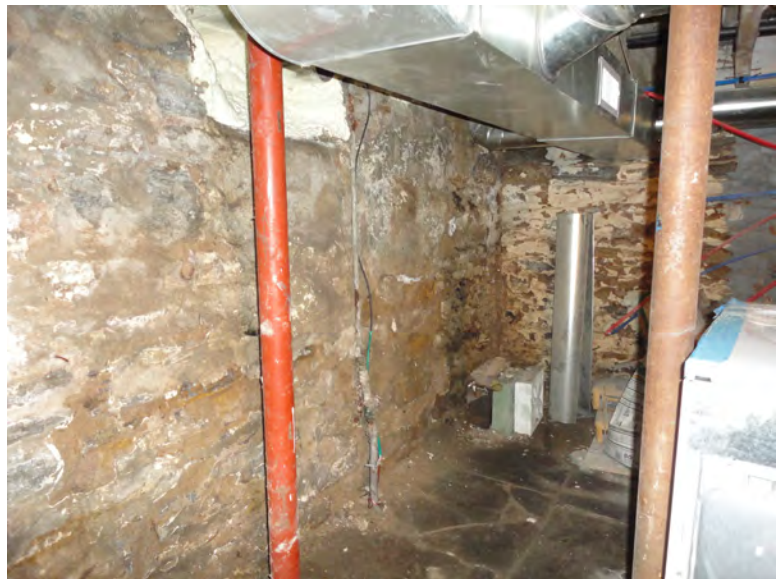
Typical Basement conditions

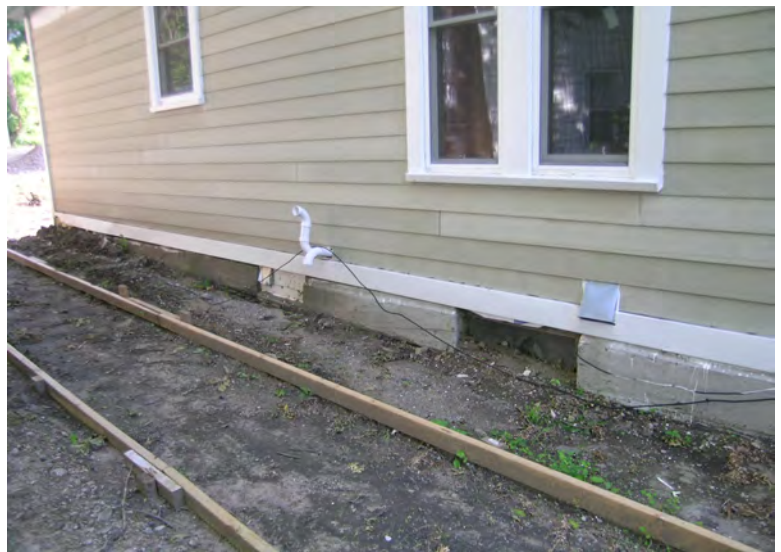
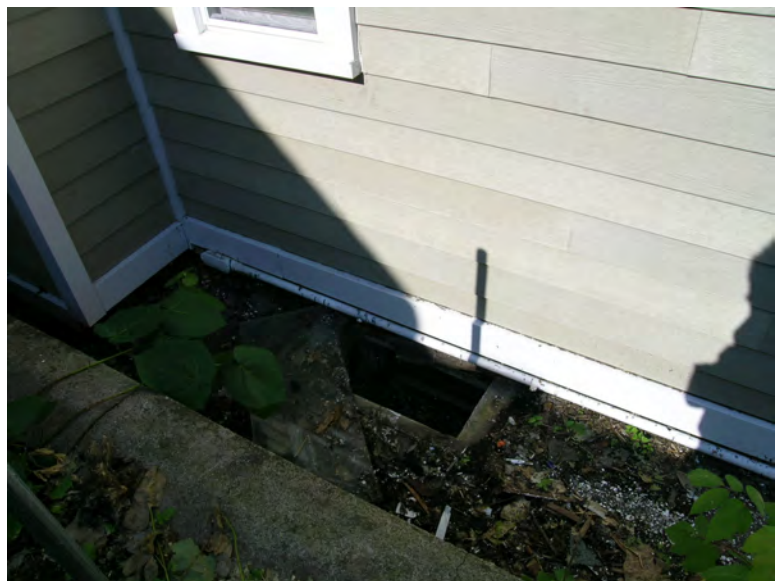
Existing Basement windows

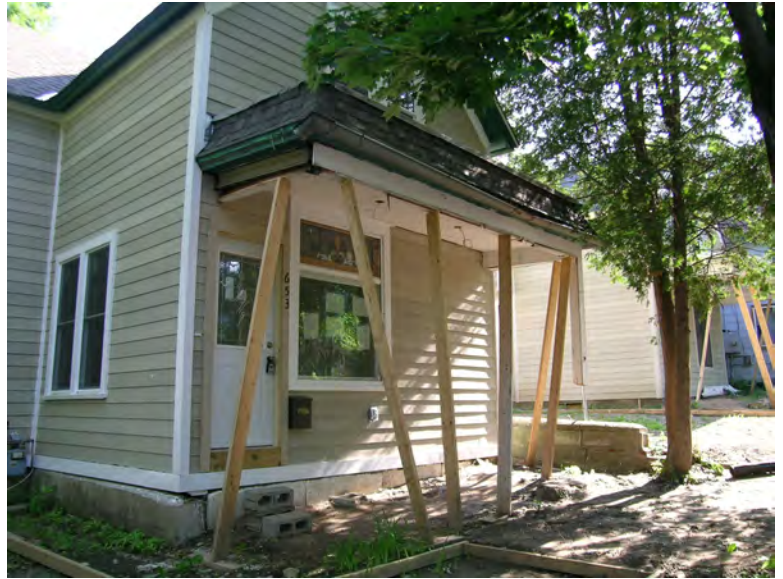
Existing Front Porch

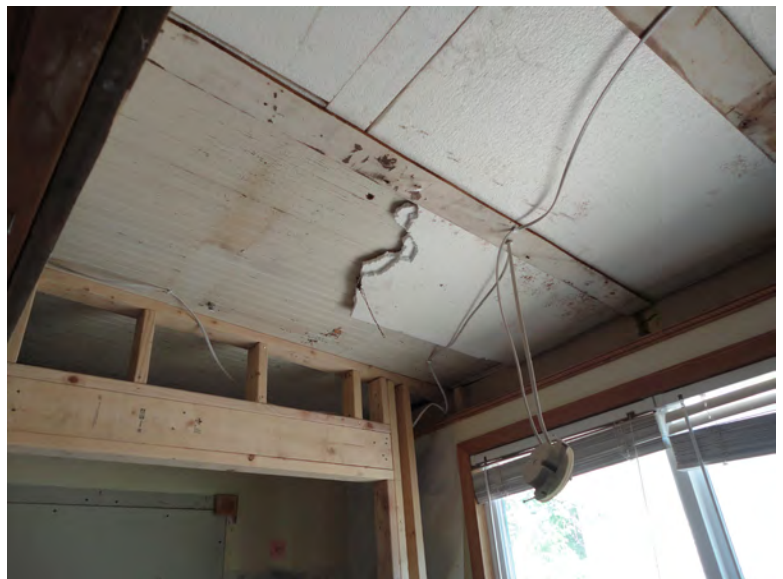
Dining A - existing ceiling and rear entry closet framing

1. Tear up a section of the plywood floor and inspect completed work; framing, insulation, footing depth, etc.
2. Complete framing of rear entry closet
3. Repair and finish of ceiling and walls
4. Install doors and windows in north wall

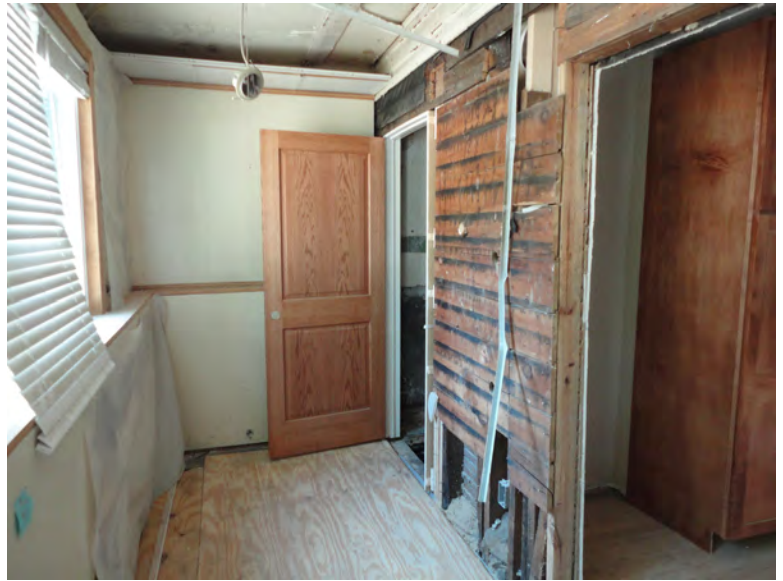
Dining A - existing walls, ceiling and north wall

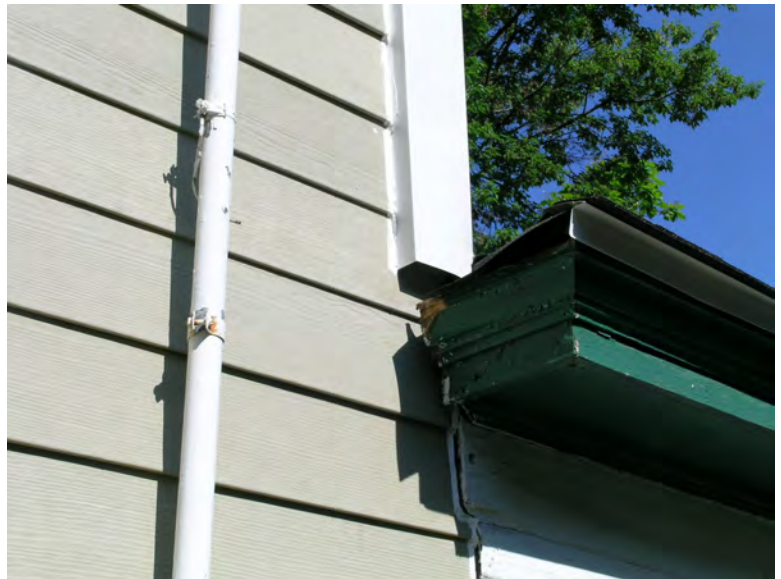
- A. House - **evidence of rotted wood at roof edge, no drip edge, roof vent is missing, and no ventilated soffits**
- B. New Garage - **verify drip edge**

No drip edge

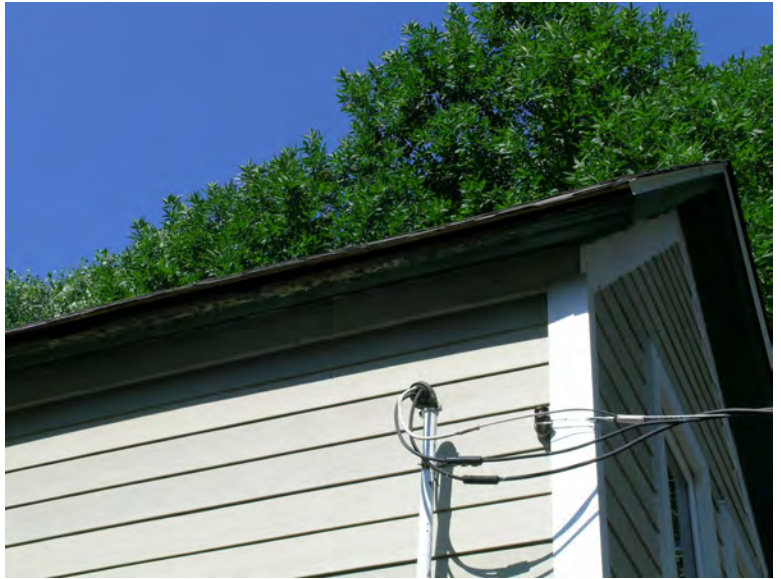
No vents

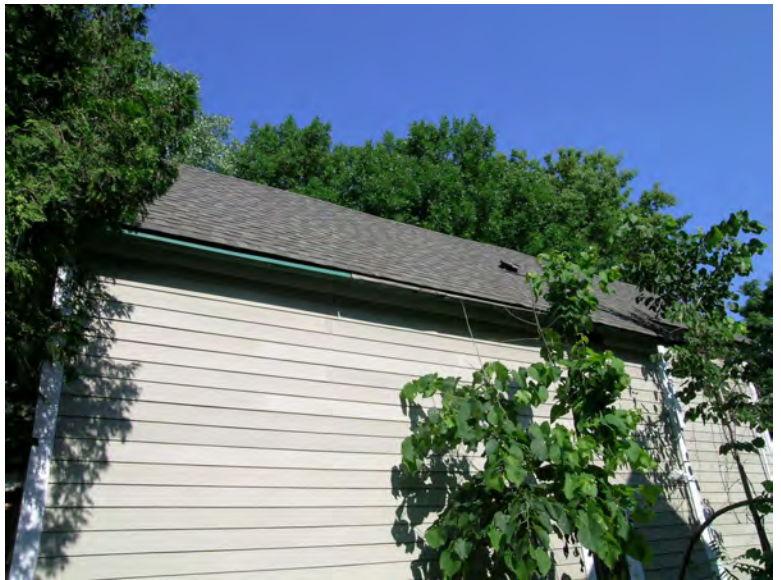
Rotted wood

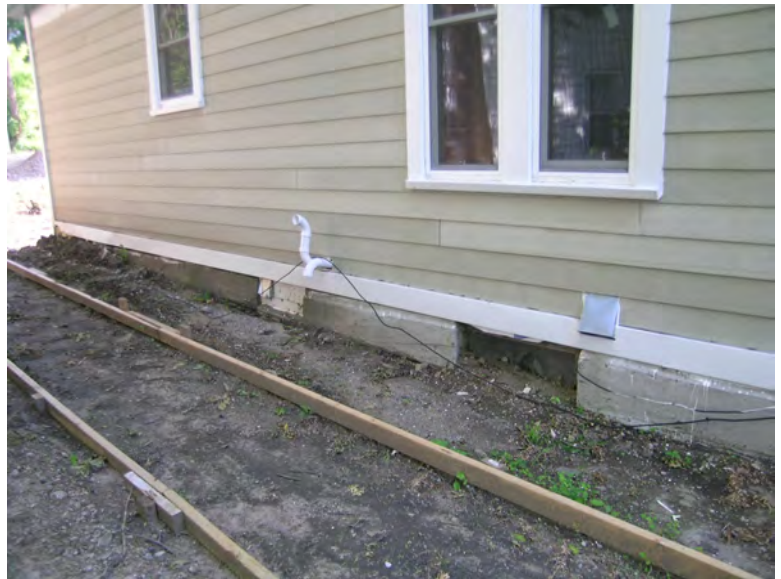
- A. House - **perimeter detailing at foundation wall to be reviewed, see note #3 on sheet A201 for flashing detail at foundation wall and concrete slab on east wall, repair/replace missing siding in various places**
- B. New Garage - **wavy siding on west wall, missing window in south wall**

Typical siding detail at foundation wall

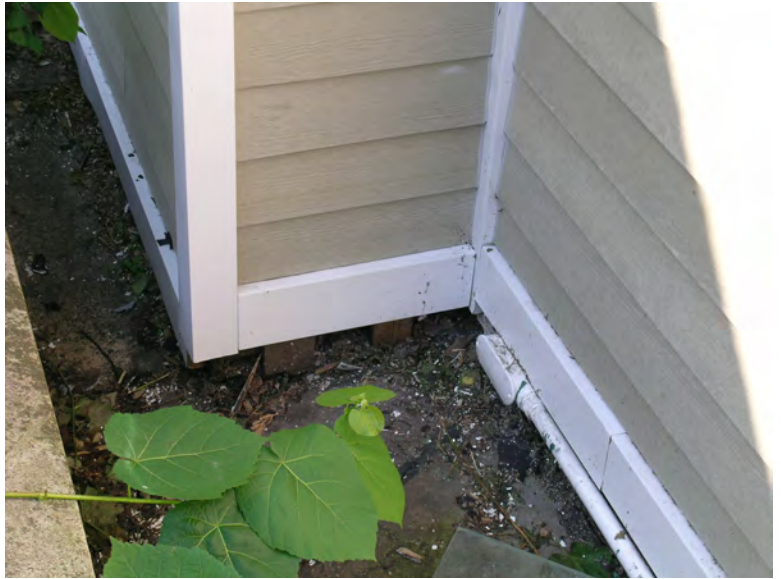
**Siding at concrete slab - east elevation**

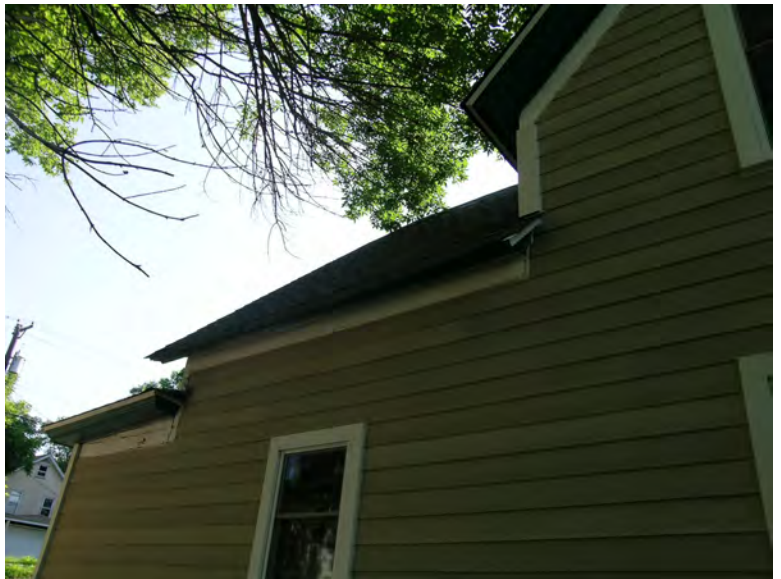
Missing siding

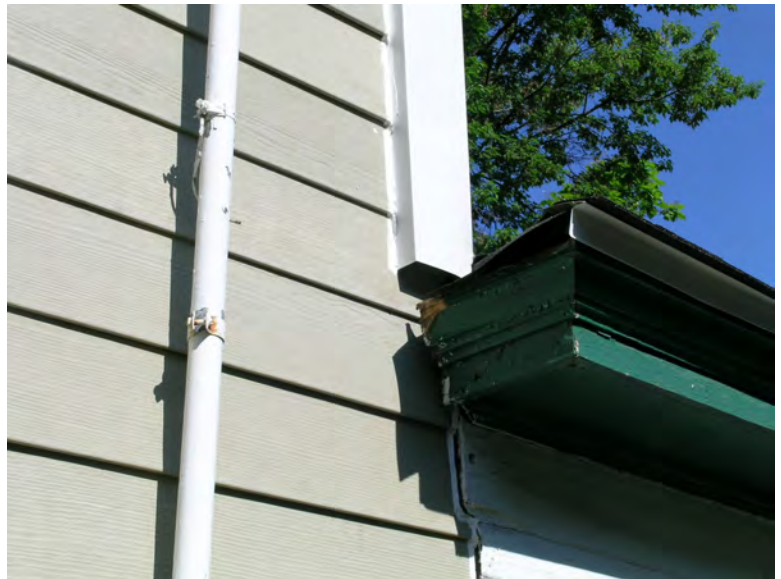
Bottom of trim is left open

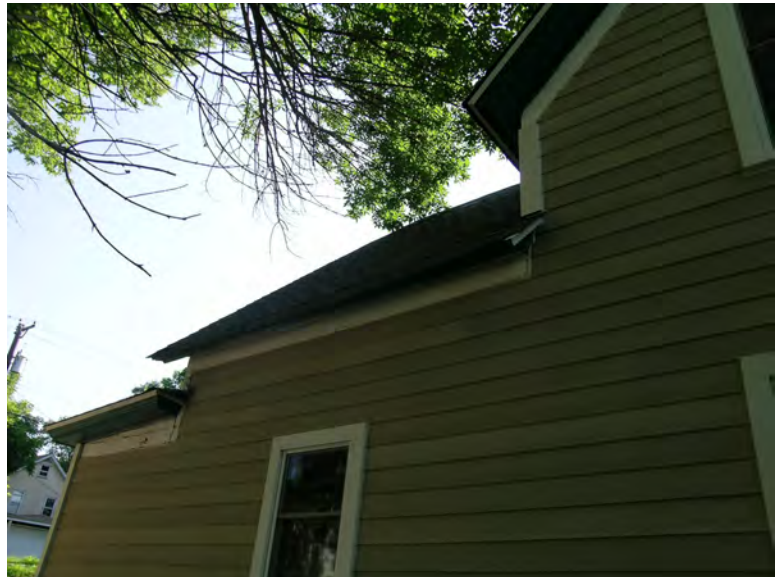
Gutters and downspouts have not been installed.

Typical roof eave

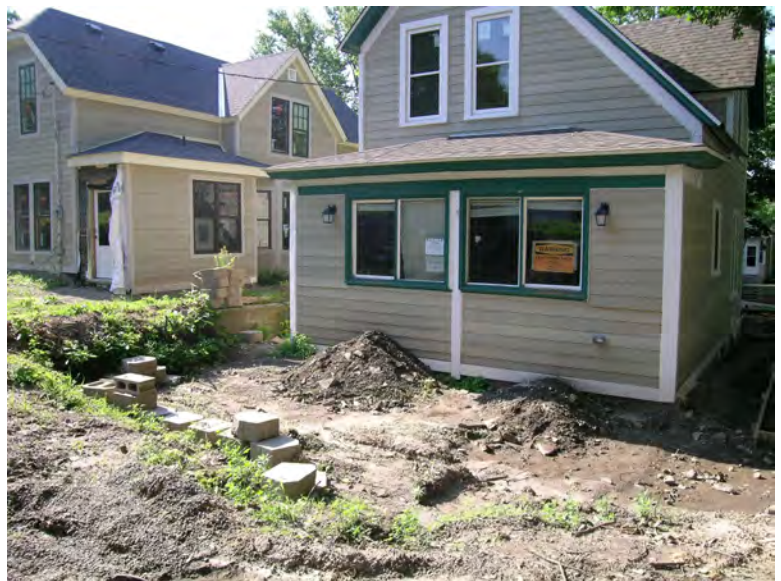
Rear entry doors not installed

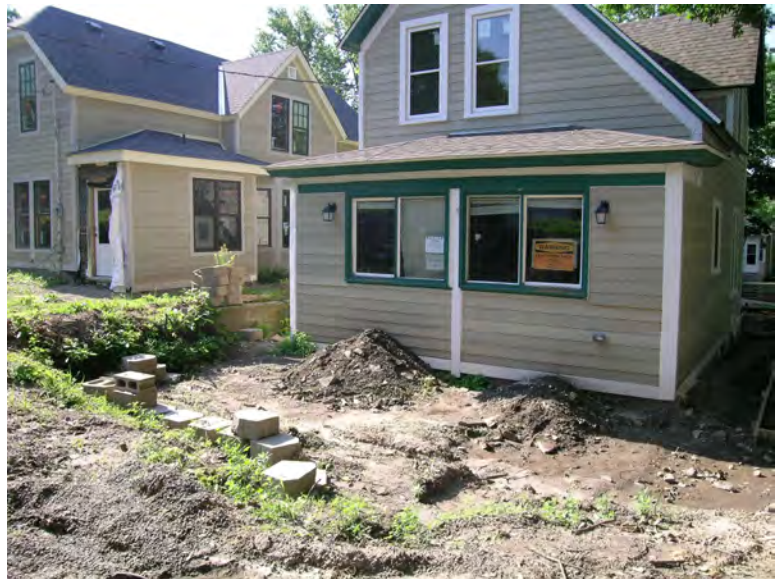
North wall Kitchen windows not installed

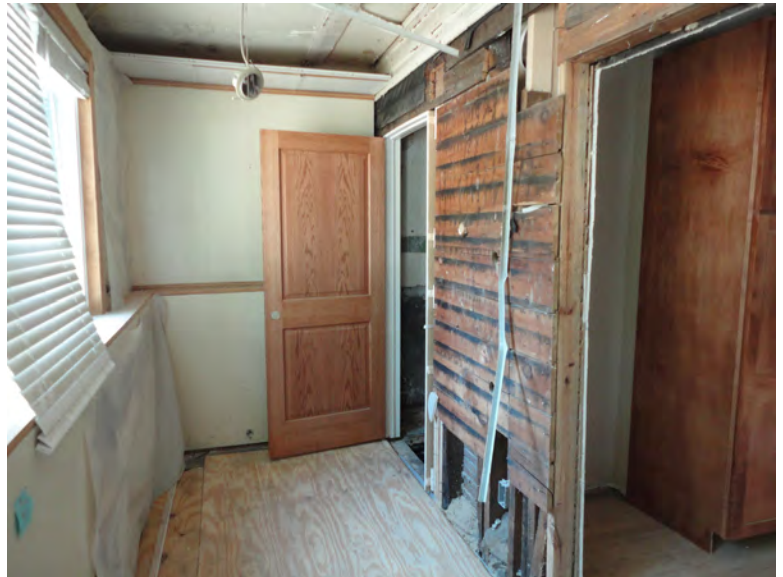
Most of the work is completed with the exception of the Dining A area: walls, ceiling and rear entry closet. There is also minor modification to the stairway wall to the Second Floor.

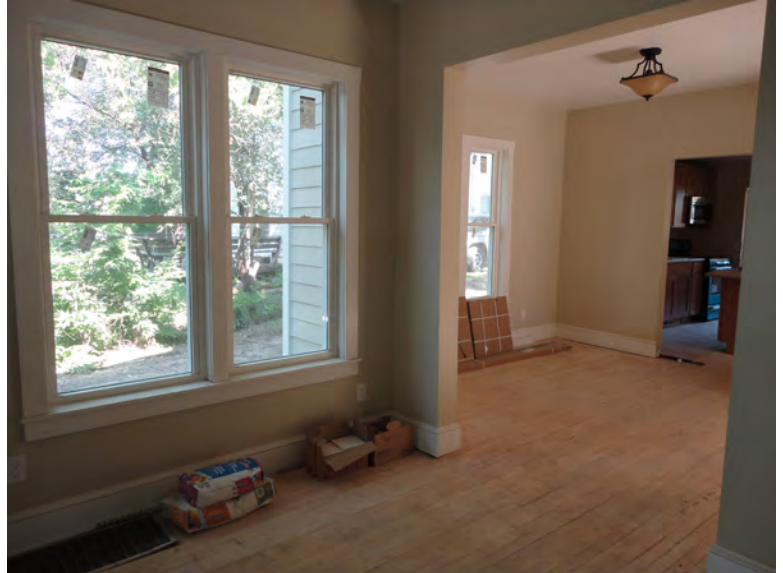
Floors are sanded but not finished. This work should be reviewed and suggestions may on how to proceed. Miscellaneous repairs are needed. **A floor material needs to be picked for Dining A.** Stair treads and risers need to be installed for both the Basement stairs and the stairs to the second floor. **Carpet has be put down in the north Bedroom, on second floor. This floor should be looked at for possible restoration.**

First Floor - Living / Dining Room

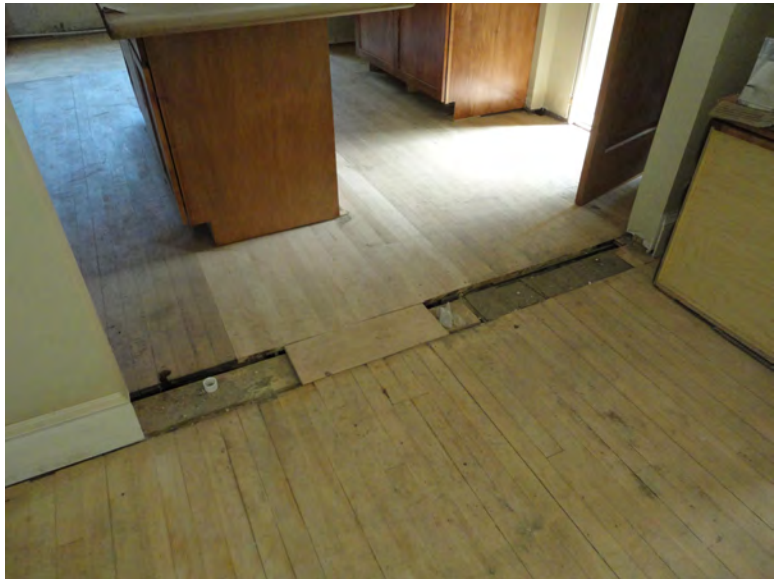
Repair on First Floor, Similar on Second Floor

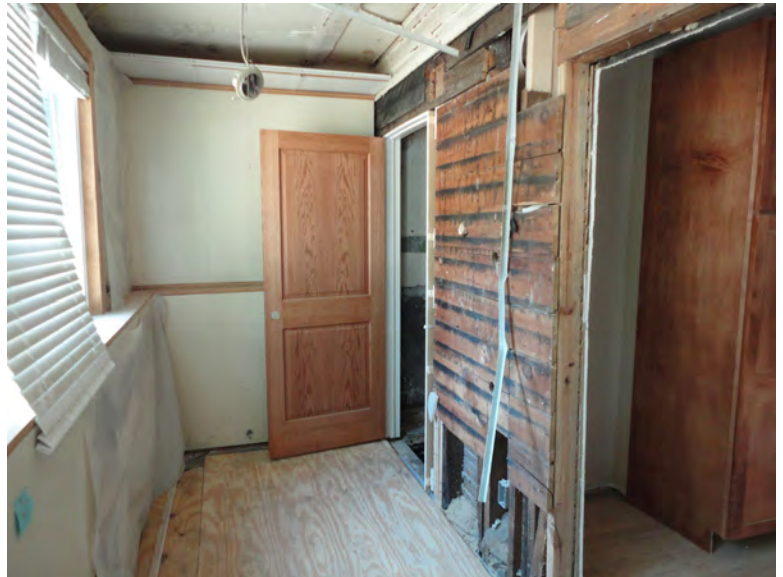
Most of the work is completed with the exception of the Dining A area: walls, ceiling and rear entry closet. There is also minor modification to the stairway wall to the Second Floor.

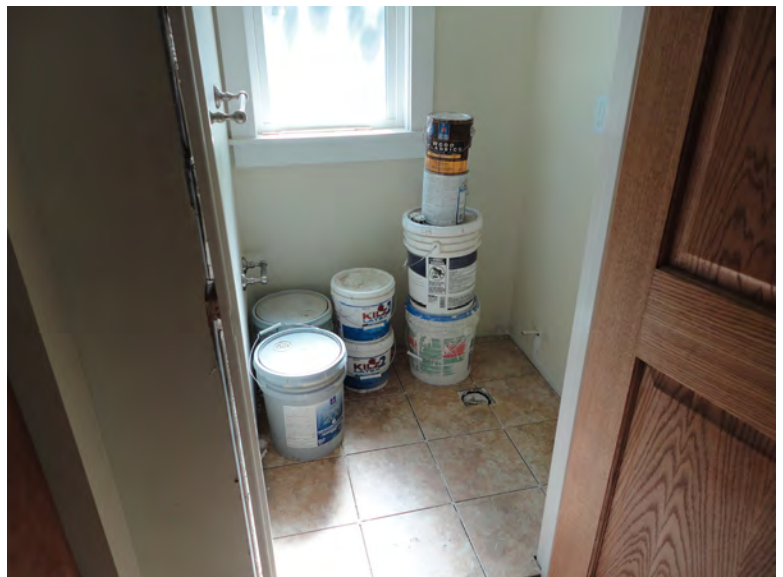
First Floor - floor tiling incomplete, grout and finishing

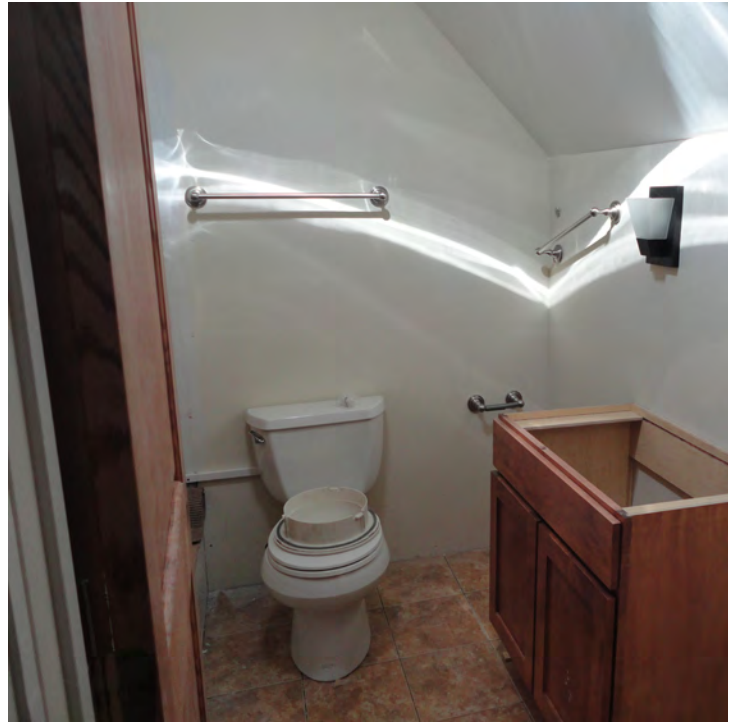
Second Floor - floor tile complete

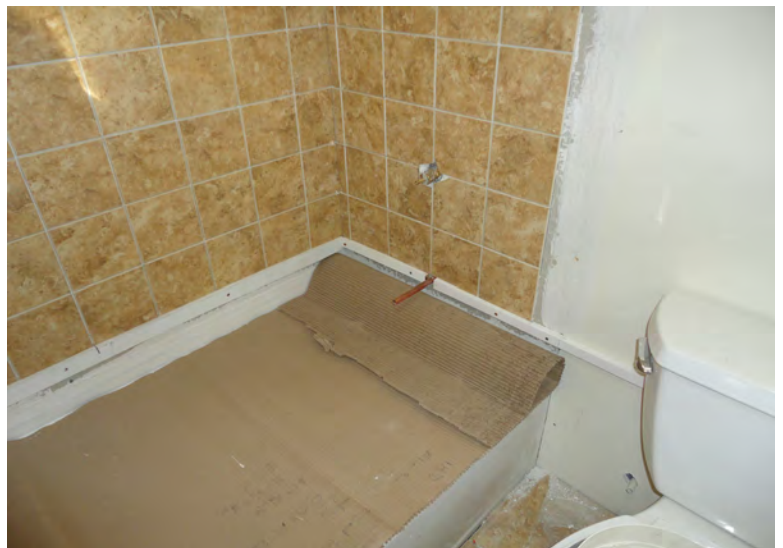
Second Floor - wall tile complete, finish detailing needed

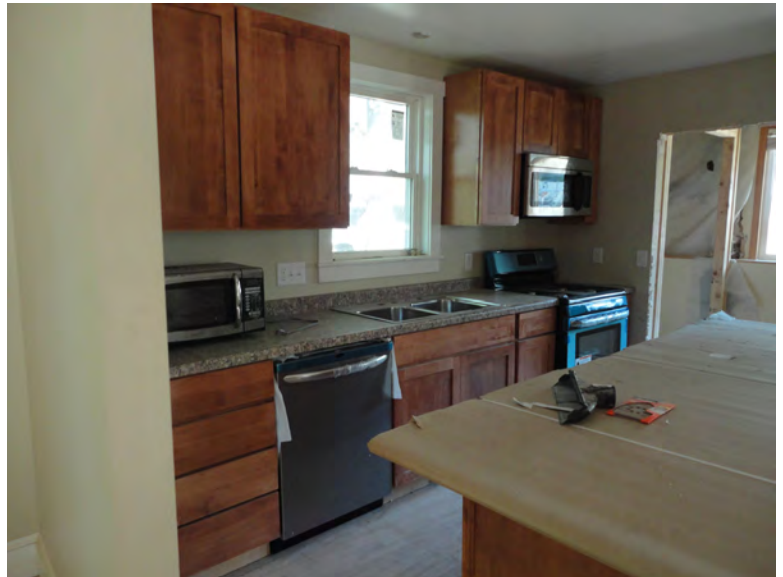
- A. Kitchen Cabinets & Counter Top; Kitchen - **partial installation**
- B. Bathroom Cabinet & Counter Top; Second Floor Bathroom - **partial installation**

Kitchen cabinets

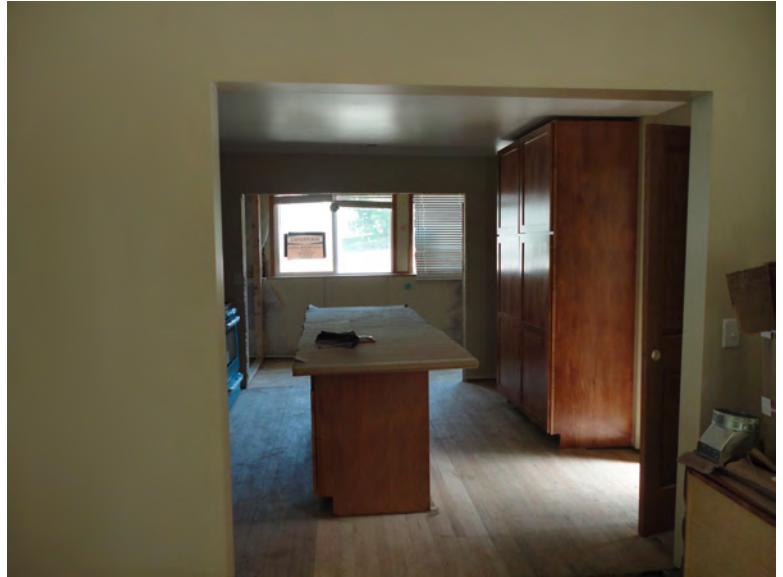
Center island and pantry

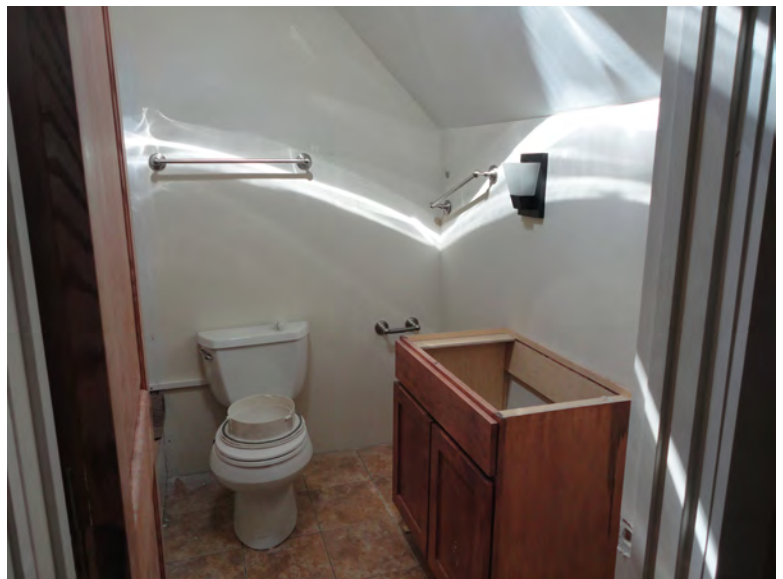
Second Floor Bathroom cabinet

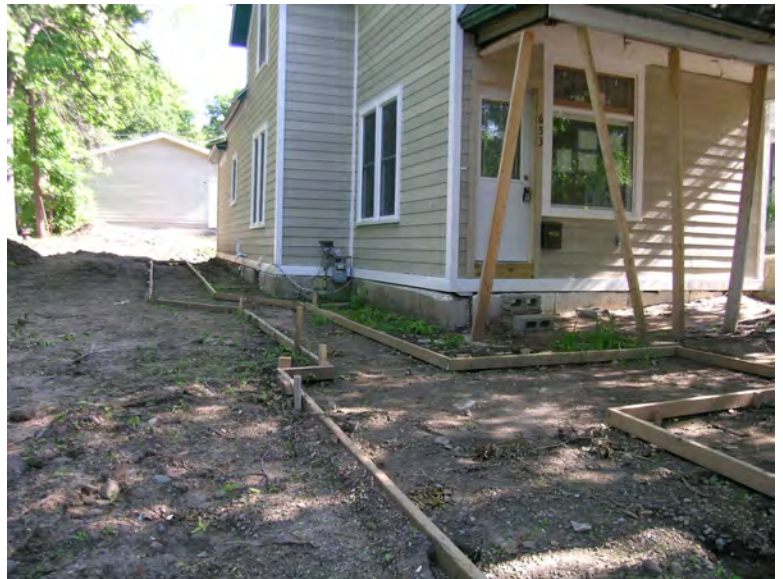
Site grading for front sidewalk

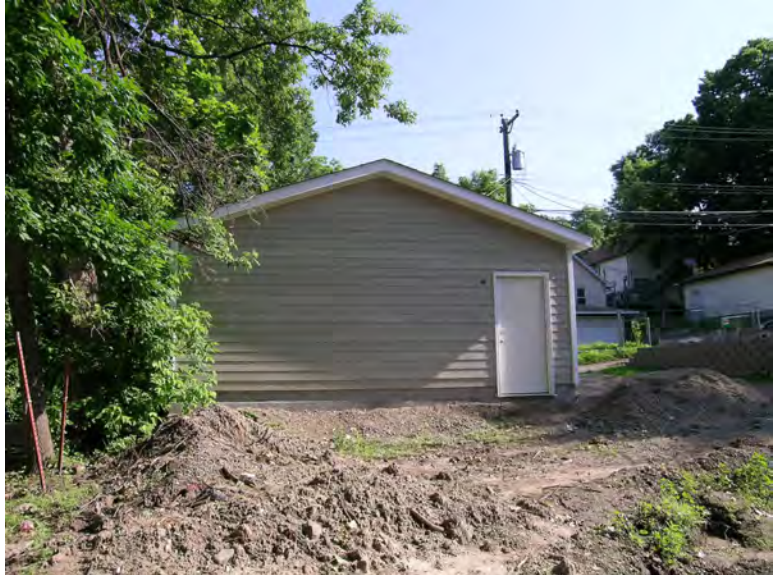
Site grading at back yard

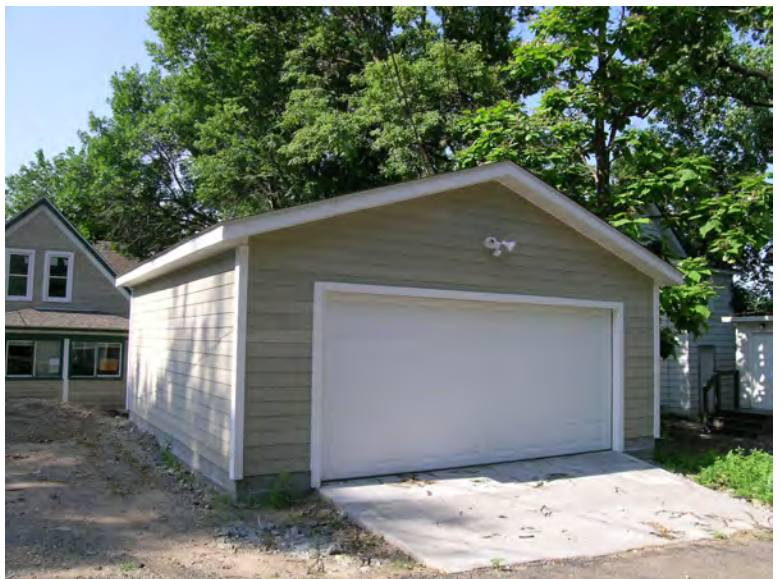
Site grading at Garage

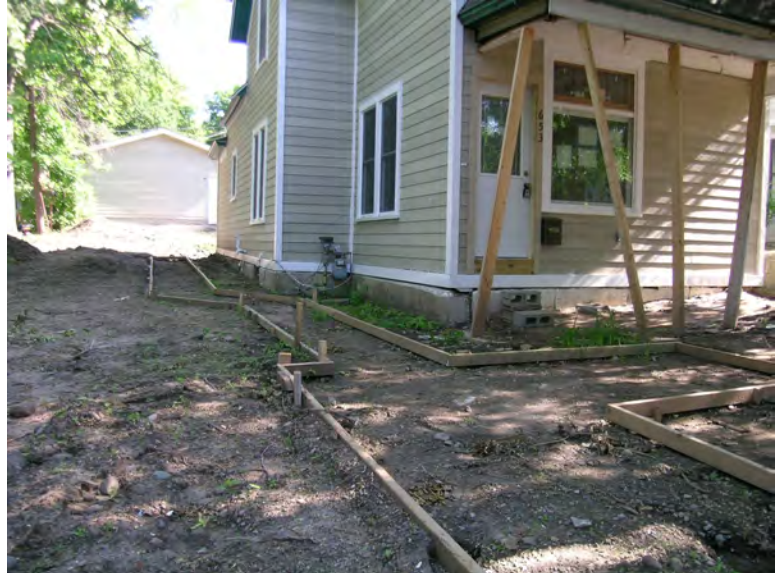
Front entry sidewalk

**ADD: Modify front entry sidewalk and steps as per drawing revisions dated October 24, 2012**

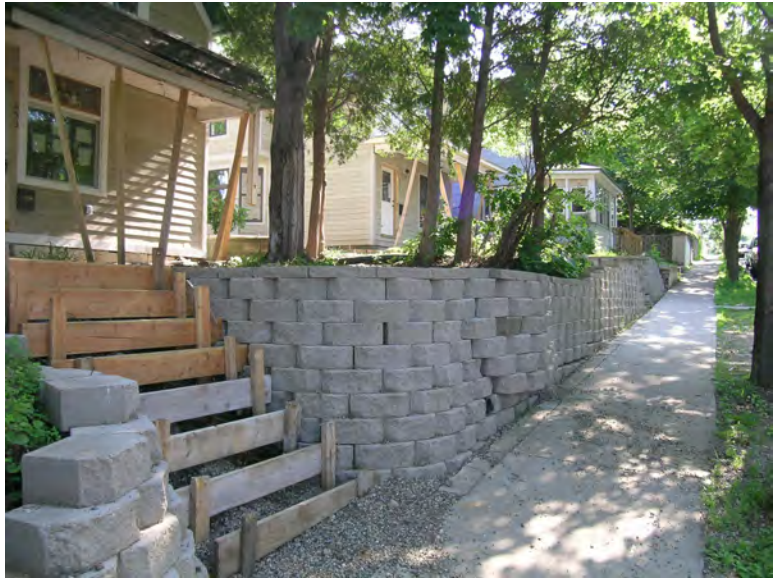
Entry step framing

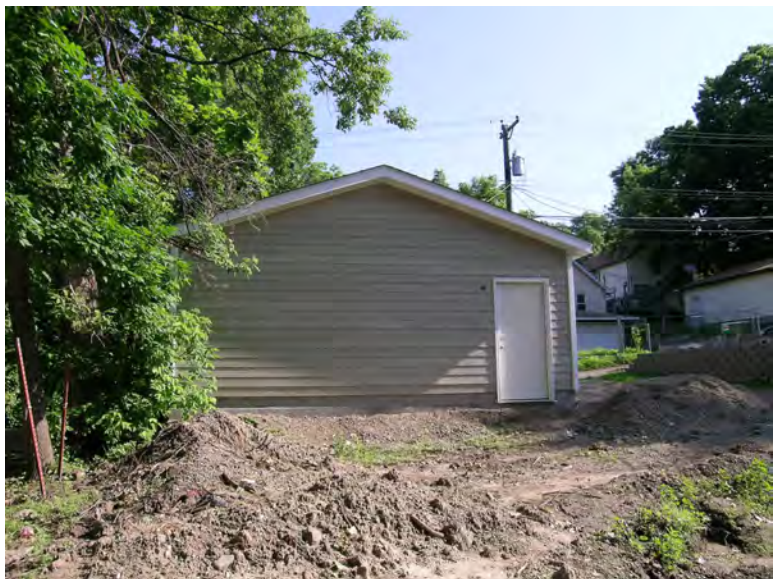
Rear entry sidewalk area

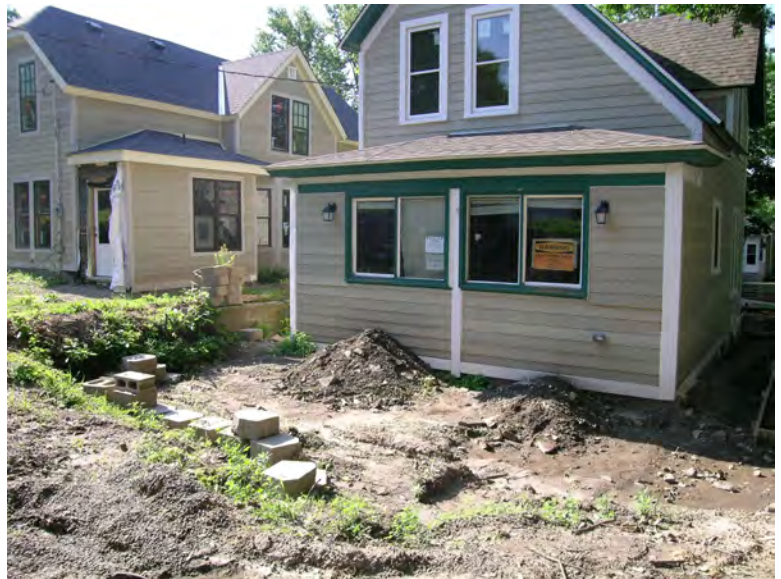
Area for precast concrete unit pavers

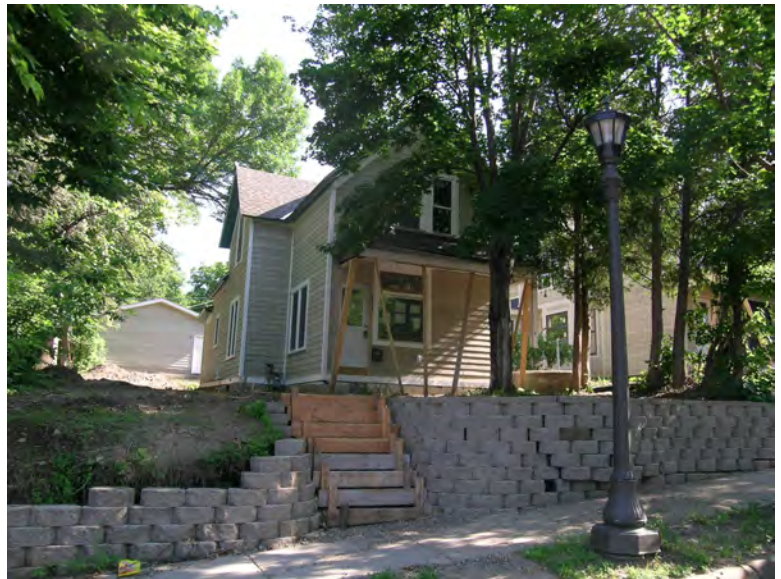
Fence location at front retaining wall

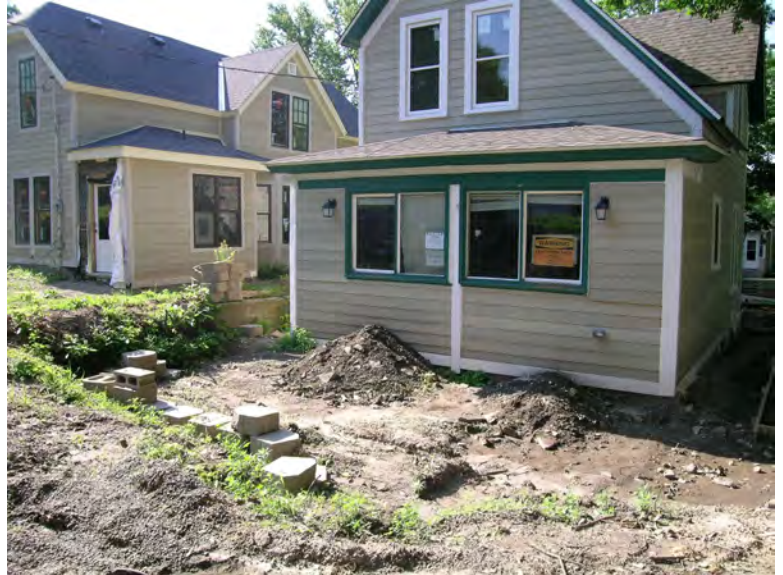
Retaining wall location at patio

**ADD:** Additional retaining wall a back patio

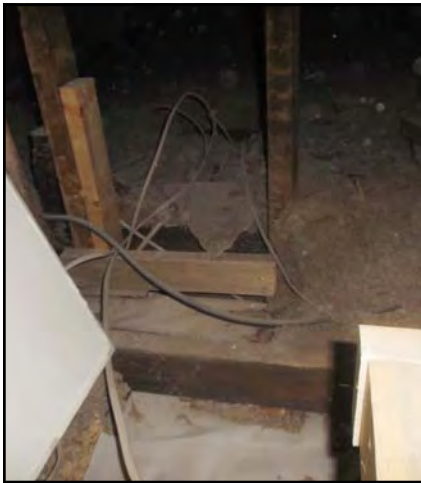
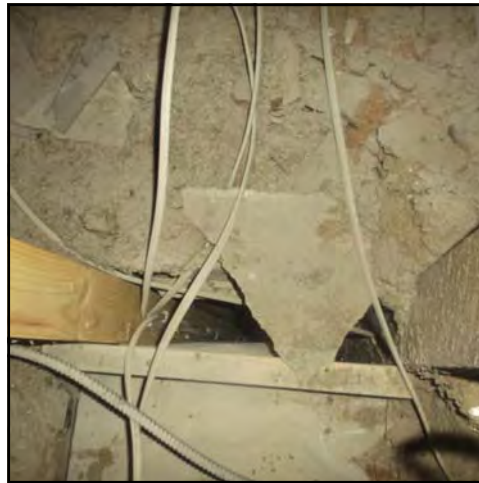
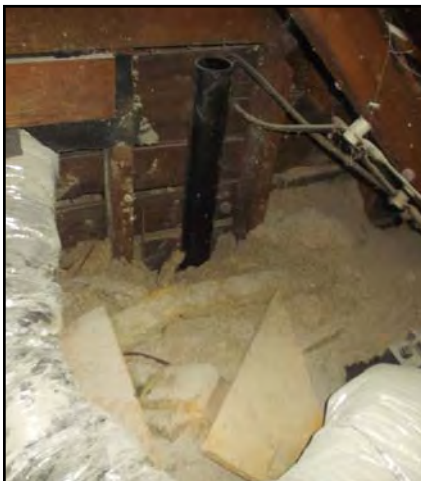
These three images indicate that attic bypass sealing was not done. The original audit indicated that the attic was at R-26. Because the insulation has been moved around so much, I was unable to tell if any additional insulation was added, but additional insulation is clearly needed to bring the whole attic up to R-50.

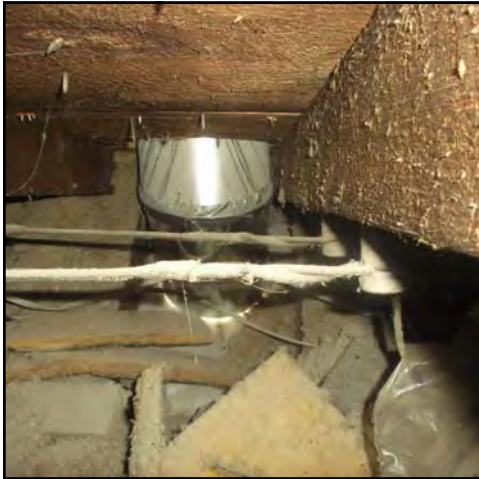
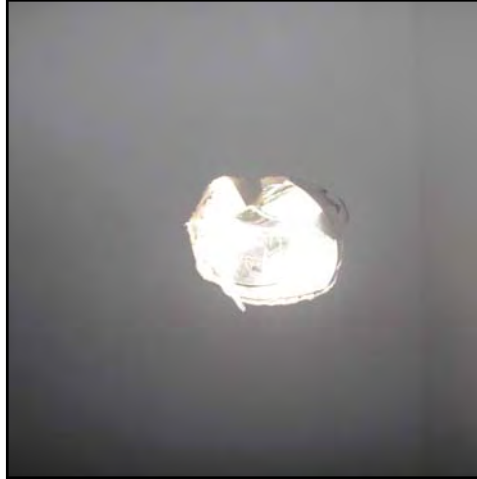
These two images are of the sun tube that was installed in the second floor bathroom. The perimeter of the sun tube at the attic floor needs to be sealed. Currently, there is no cover to the sun tube and birds could easily get into the house.

Unit has been installed. Review installation, flashing, mounting, sealing and surrounding insulation. Repair/replace as necessary.

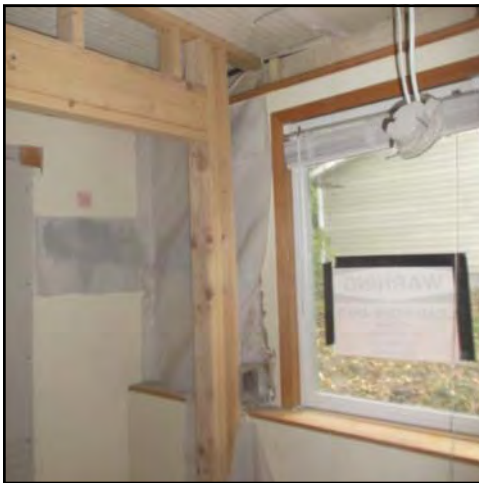
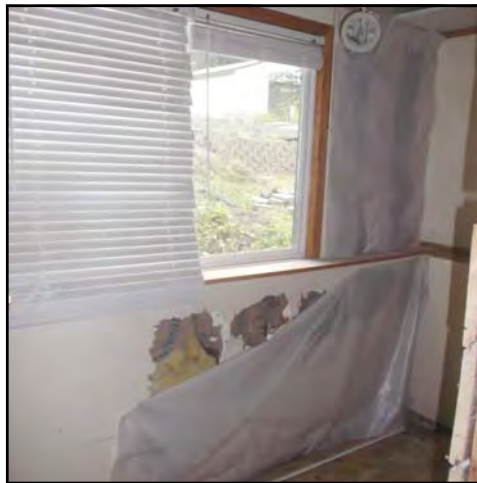
Since the drywall is damaged in the back walls of the addition, it is recommended that the damaged portions be removed and that the wall be re-insulated with new fiberglass batts.
